Mercedes W123 Glow Plug Fuse and Fuse Box, Early Style Replacement

On the diesel W123 cars there is a glow plug fuse that may break and need replacement. In addition there is a fuse box on the early style cars that may deteriorate from excess heat and need replacement. Learn how with this guide.

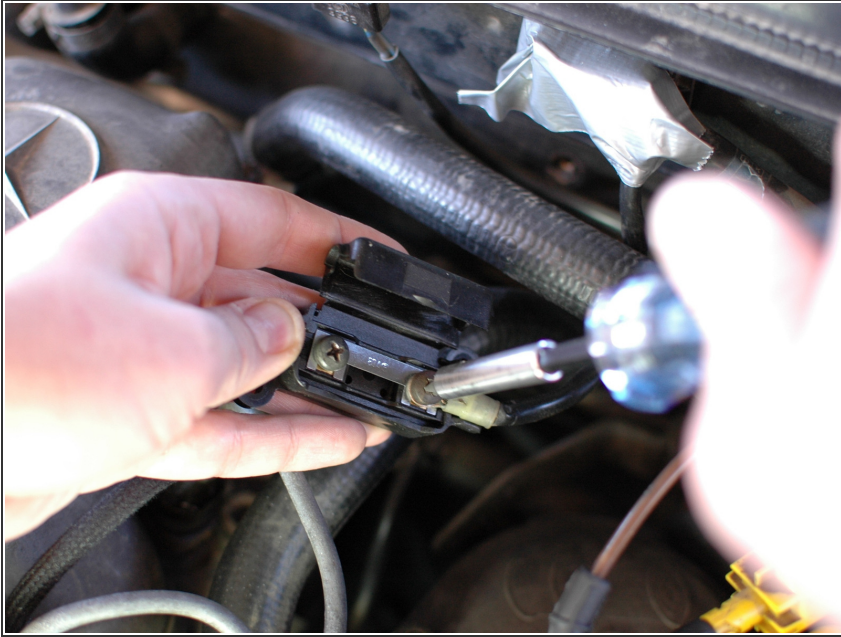
Step 1 — Glow Plug Fuse and Fuse Box, Early Style

- The fuse box on early W123 cars, those with the glow plug relay inside the car and under the dash, usually 1980 and earlier, are located on the firewall back behind several of the soft rubber heater hoses. The location makes it difficult to photograph the fuse box when installed.
- To uninstall the fuse box simply locate it on the firewall and remove the two Phillips head screws that hold it to the firewall. These are the Phillips screws located on the upper right and lower left corners of the fuse box, outside of the fuse box cover.
- Once the fuse box is removed from the firewall it can be gently pulled forward for easier access to the screws holding the wires and fuse in place inside the box. As shown, once you've pulled the box out from under the coolant hoses you can remove the two remaining Phillips head screws and then remove the fuse box and old fuse.

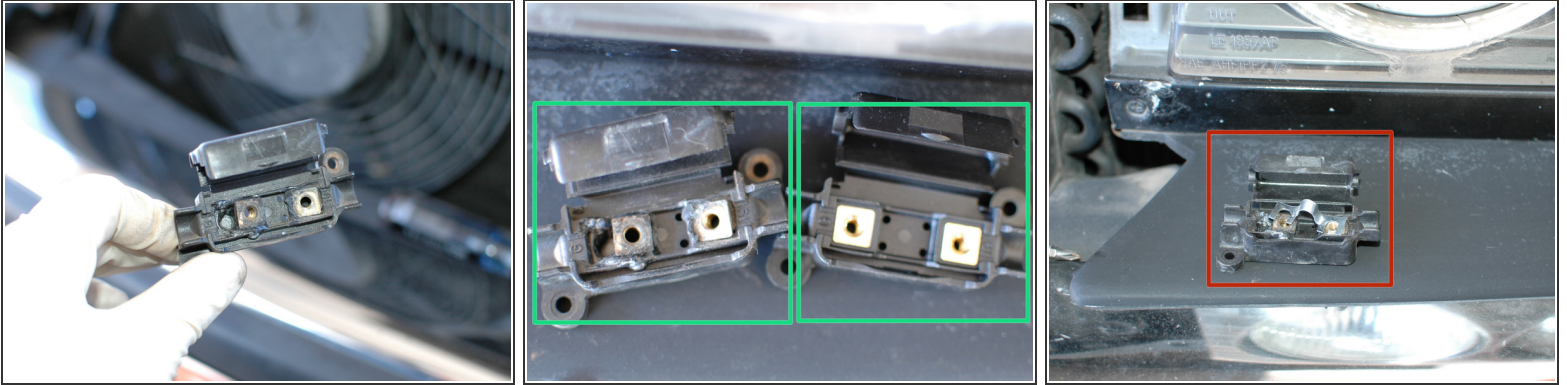
Step 2

- With the fuse box removed it and the fuse can be inspected. This fuse box was removed because excess heat caused the fuse box plastic to melt. This allowed the copper fuse connection on the left to be pulled to the right within the body of the fuse box. Eventually the two copper sections would touch, bypassing the fuse.
- The old, damage box is shown on the left while the replacement box is shown on the right.
- See how the fuse is bent in the middle as it's left-side connection was pulled to the right.
- In this case this was caused by the timer on the glow plug relay no longer functioning after the glow system on the older style glow plug system after it was converted to the fast glow plug system. The glow plugs stayed hot, with 12V going through the fuse, while testing the window regulators on this car.
